A LICHEN SURVEY OF SELECTED AREAS OF CORFE CASTLE

**Bryan Edwards
Dorset Environmental Records Centre**

July 2014

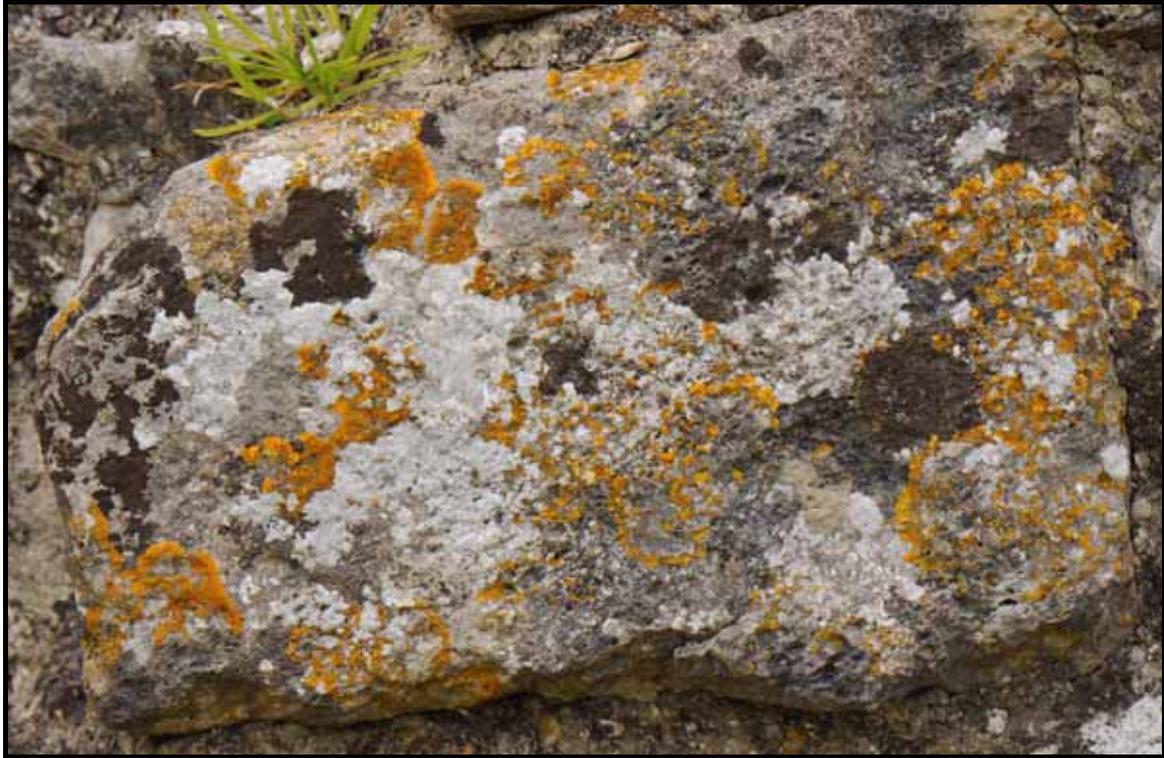
FIG 1. Hard limestone block on inner face of eastern wall north of Horseshoe Tower showing a well developed lichen community of well lit limestone (the *Caloplacetum heppiana*) with white patches of *Aspicilia calcarea*, yellow *Caloplaca aurantia* and *C. flavescens* and the brown-black *Verrucaria nigrescens*.

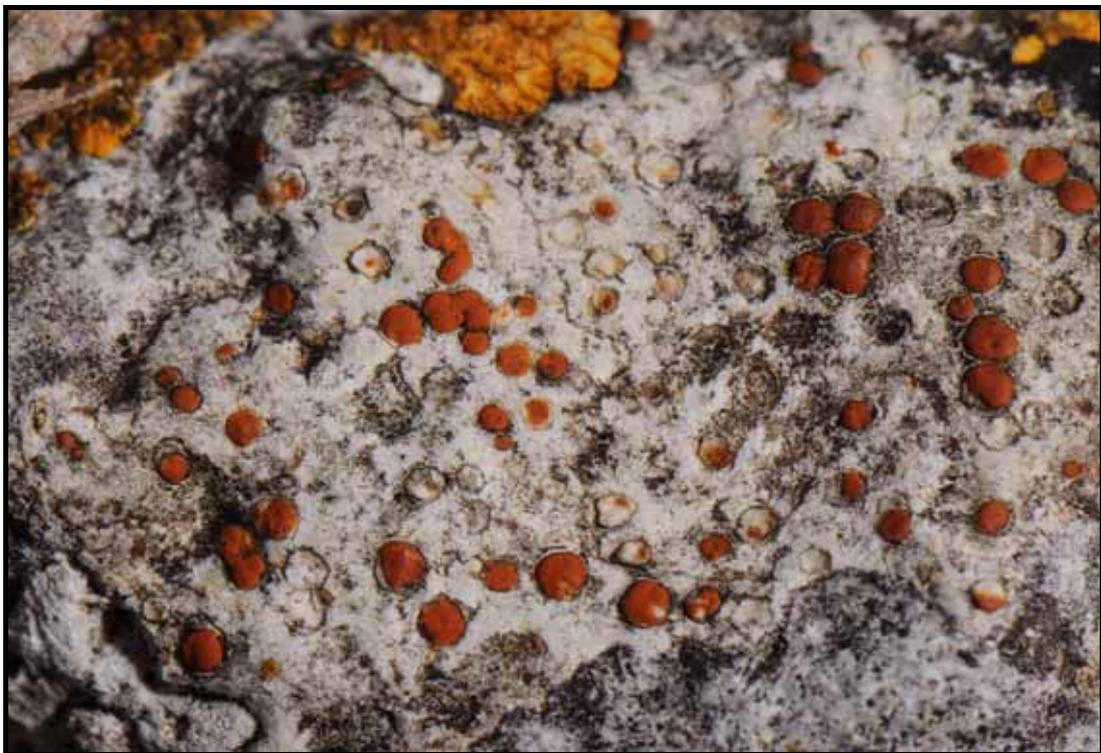
FIG 2. *Protoblastenia calva*, a good indicator species of the better developed *Caloplacetum heppiana* communities found on the least disturbed areas limestone wall, especially the Eastern Wall.

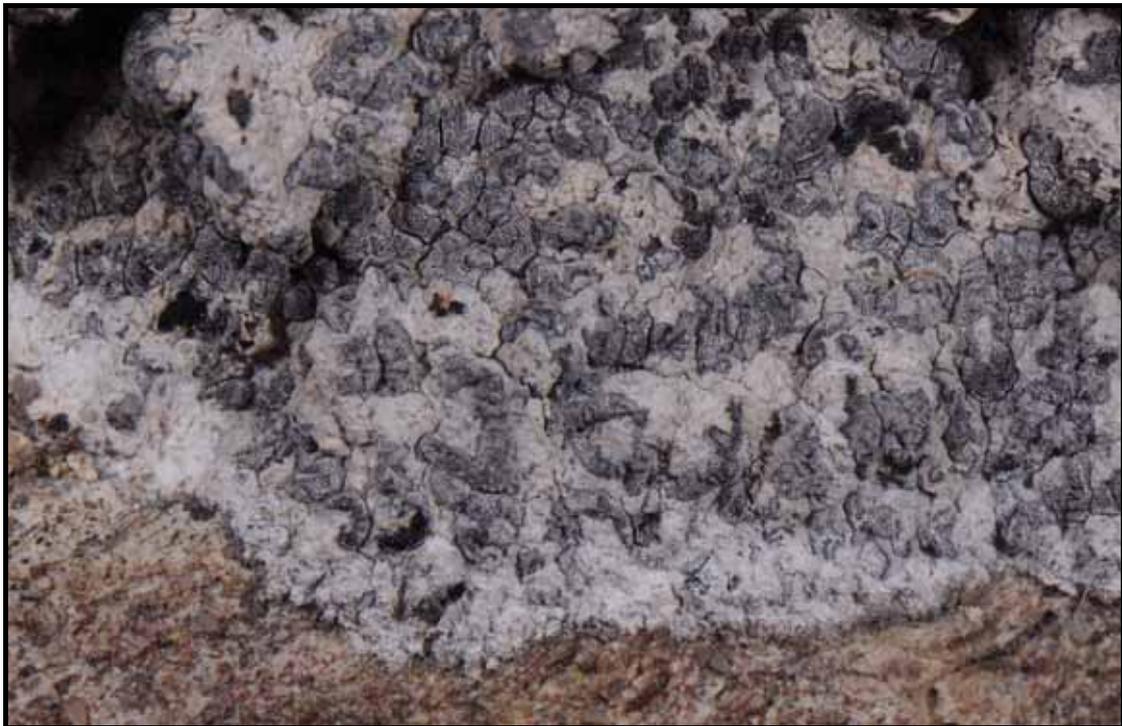
FIG 4. *Lecanographa grumulosa*, Nationally Scarce, west of Gatehouse. This species has been known from the Castle since the 1880s.

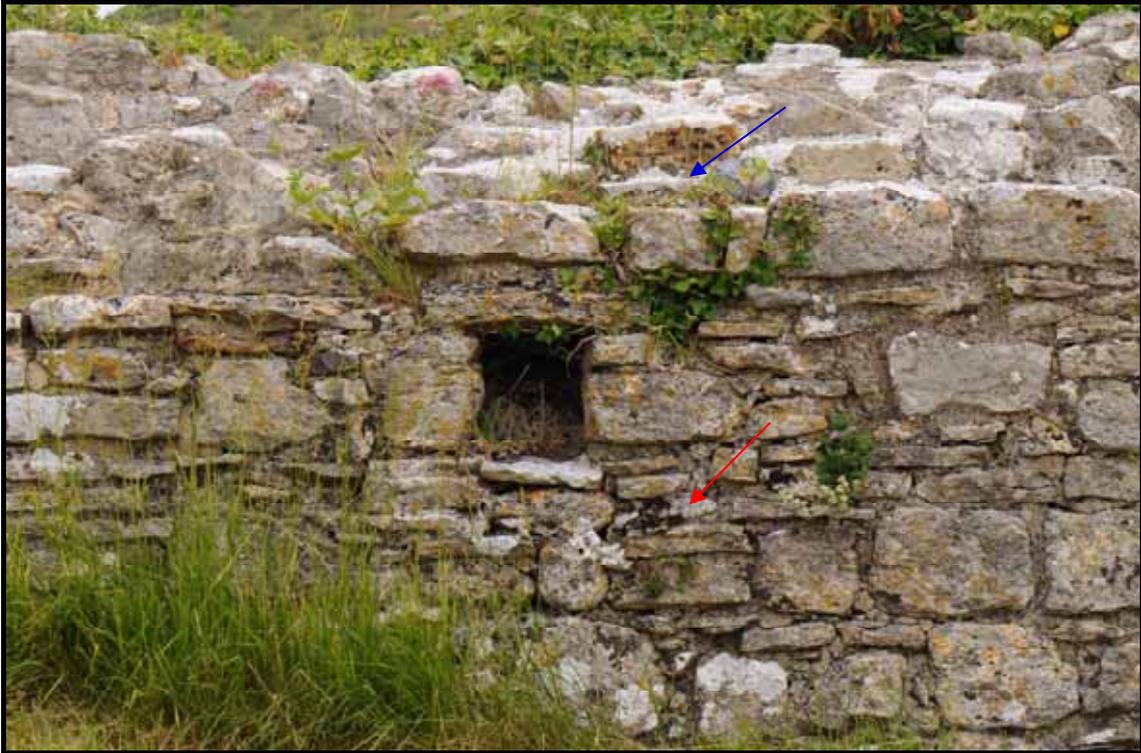
In places where water seeps through the stone jelly lichens are present with *Collema auriforme*, *C. crispum*, *C. tenax*, *Leptogium plicatile* and *Placynthium nigrum* plus *Toninia aromatica* and *Agonimia tristicula* which is often found overgrowing the *Collema* thalli. This community of lichens with a blue-green photobiont is referable to the ***Placynthietum nigra***. The most important member of this community at Corfe Castle is the Red Listed *Collema fragile* which was noted in two places in the 2007 survey and was found at a new site during the present survey on the eastern wall south of Plukenet Tower. (see figs 5 & 6).

FIG 5. Eastern Wall, site for *Collema fragile*, RDB Vulnerable, S41, on vertical stone indicated by the red arrow. The blue arrow shows the location of the Nationally Scarce *Hymenelia prevostii* on the horizontal stonework on the wall top. Ideally the patch of Ivy on the wall should be removed as it could potentially harm the lichens (and the wall).

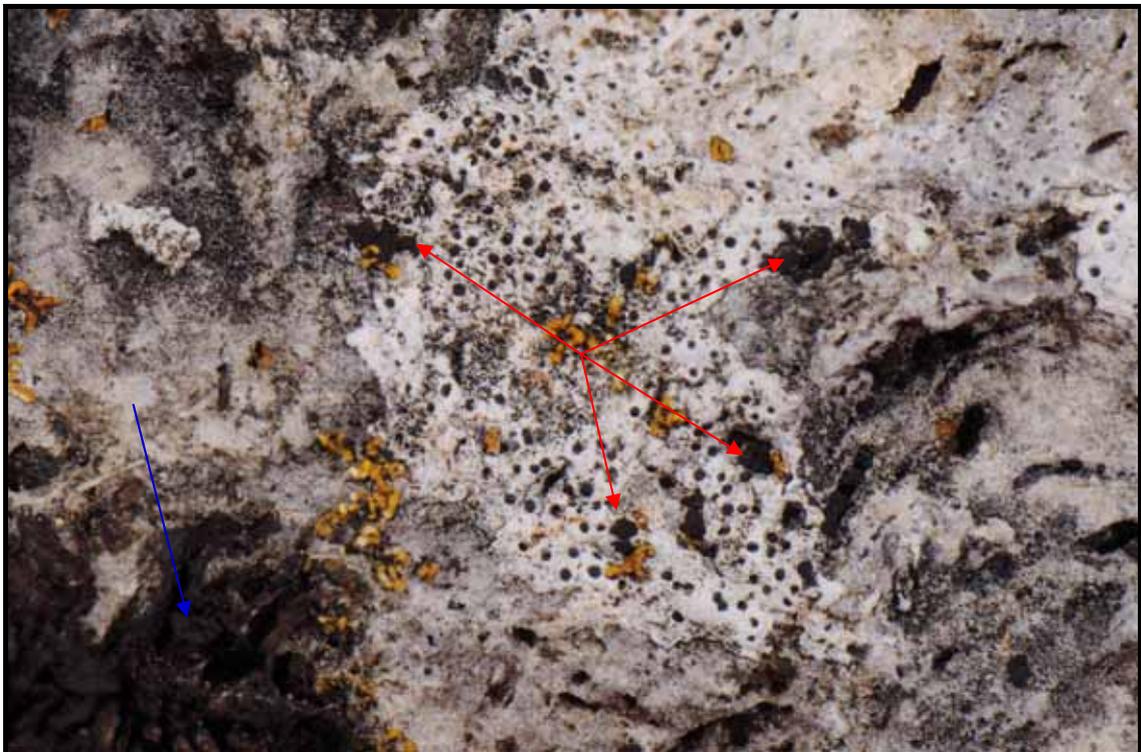
FIG 6. Very small and fragmented thallus of *Collema fragile* (red arrows), with the much larger *Leptogium plicatile* in the bottom left corner (blue arrow).

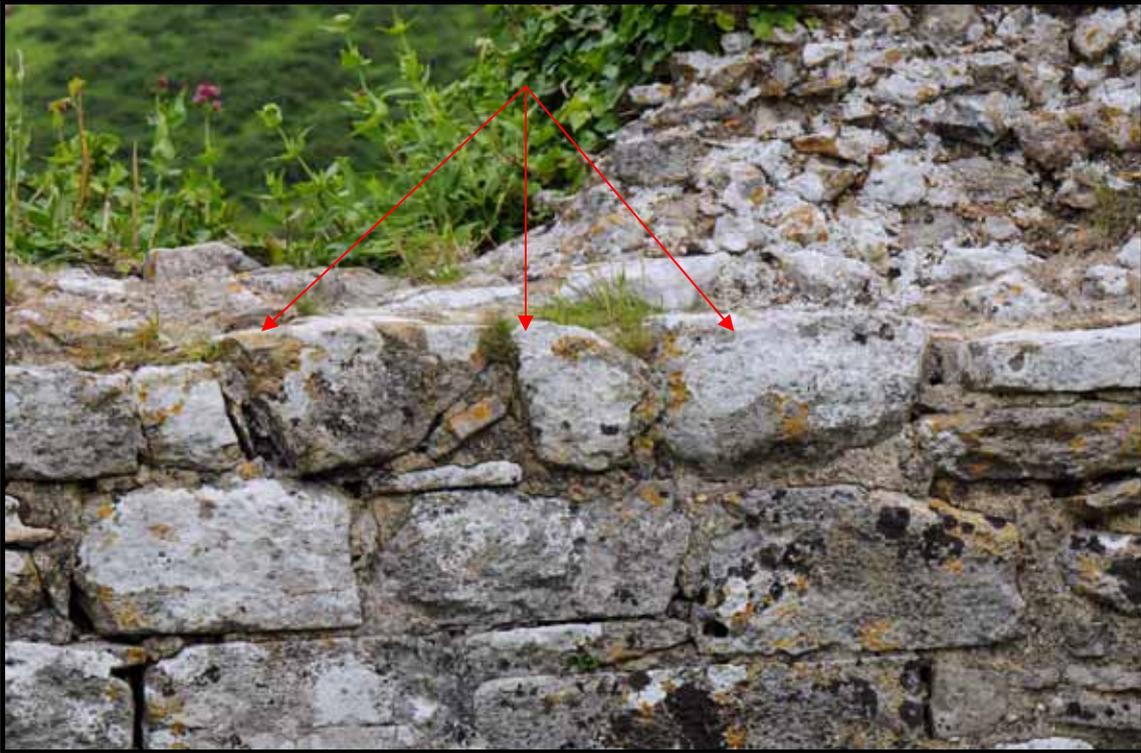
FIG 7. Area of wall supporting the Nationally Scarce *Caloplaca ochracea* on the horizontal surfaces of the top layer of stones.

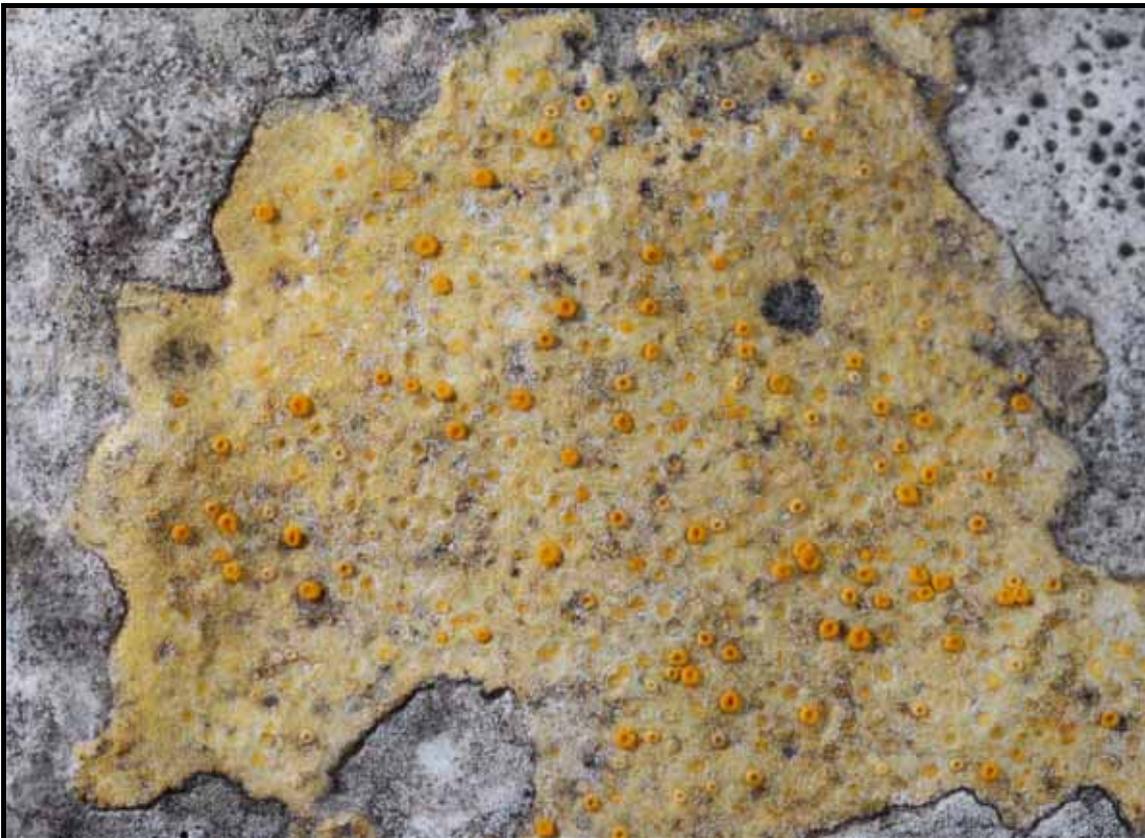
FIG 8. *Caloplaca ochracea*. A Nationally Scarce lichen of well-lit hard limestone, preferring horizontal surfaces. Found in suitable habitat in southern and western Britain north to Argyll. It is easily confused with the much more common *C. dalmatica*.

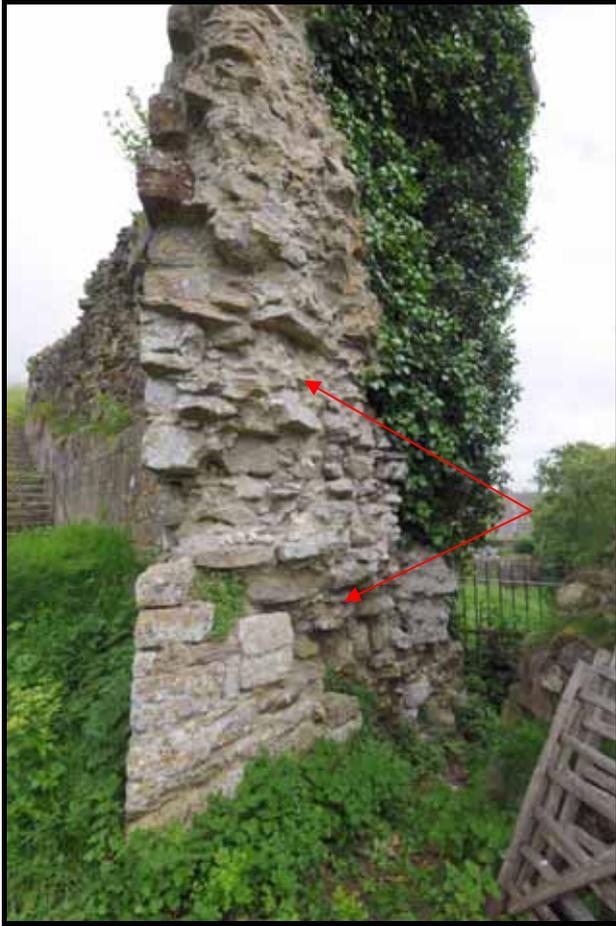
The inner wall between the Outer Gatehouse and the First Tower has the best examples of the Dry Limestone Communities (the ***Dirinetum stehammariae*** and ***Leproplacetum chrysodetae***). The broken western end of the section has abundant *Dirina massiliensis* f. *sorediata* with a local abundance of the nationally scarce *Lecanographa grumulosa*, plus the local *Opegrapha mougeotii* and an un-named taxa with a pale pink sorediate thallus. Further along dry recesses on the north face have *Caloplaca chrysodeta* and *C. xantholyta*, plus a little *Botryolepraria lesdainii*.

FIG 9. The western end of the wall between the Outer Gatehouse and First Tower. The sheltered dry surfaces of the stone and old mortar support a good population of the Nationally Scarce *Lecanographa grumulosa* and a small amount of *Opegrapha mougeotii*.

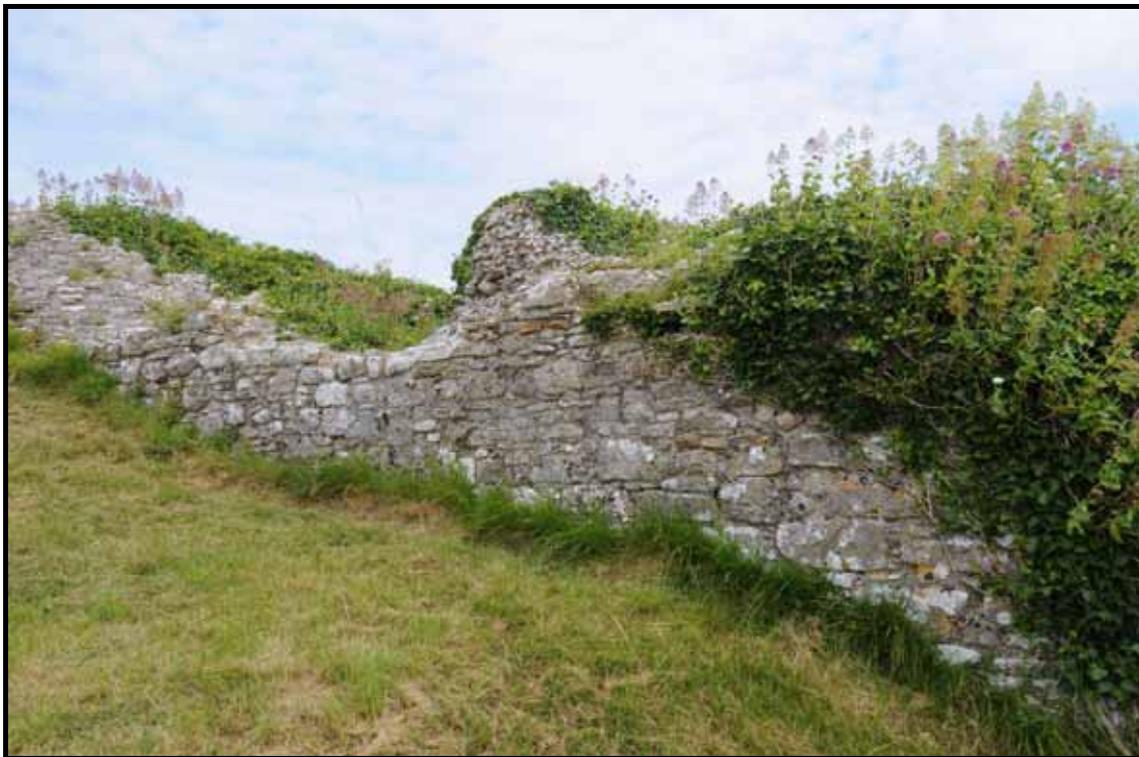
FIG 10. Section of the inner face of the Eastern Wall. This section of the wall supports three Nationally Scarce species, *Clauzadea metzleri* on the vertical face, plus *Caloplaca ochracea* and *Toninia episema* on horizontal surfaces on the wall top. The encroachment of Ivy on to the wall is a concern and if left will be detrimental to the lichen interest.

- When large stones are removed but are to re-used they should be replaced in the same aspect
- When re-pointing, the mortar should be in keeping with the particular stone type and the surfaces of the adjacent stones should be kept as clean as possible
- If possible areas should not be covered up with dark non-breathable coverings for long periods
- Any soil or dust accumulated on the stones adjacent to the areas of work should be removed when dry using a soft brush
- In several areas, notably the stretch of wall between Outer Gatehouse and First Tower and the Eastern Wall south of Plukenet Tower there are extensive patches of Ivy which threaten some of the rarer lichens found on the Castle. If these are not a threat to the stability of the walls then they should be cut back from the areas supporting important lichens.
